DOE/NE-ID-11145  
March 2004

U.S. Department of Energy  
Idaho Operations Office

## ***Fiscal Year 2003 Operations and Maintenance Report for the Central Facilities Area***

**March 2004**

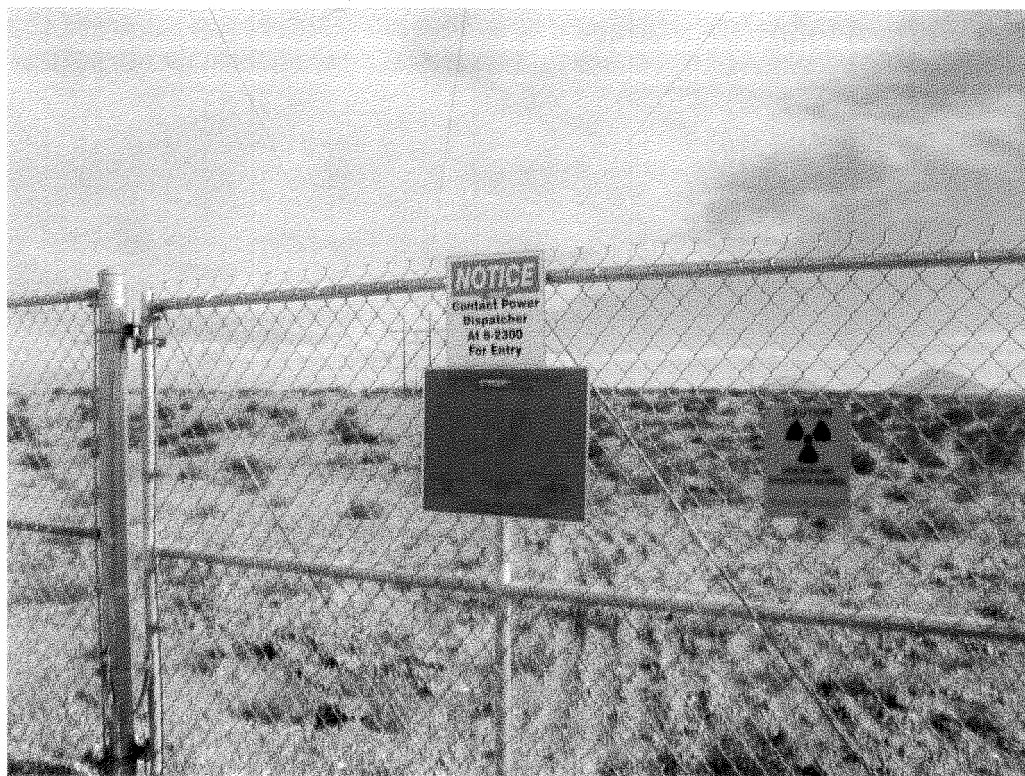
PB190828

Figure B-1. CFA-08, southwest corner, looking northeast.

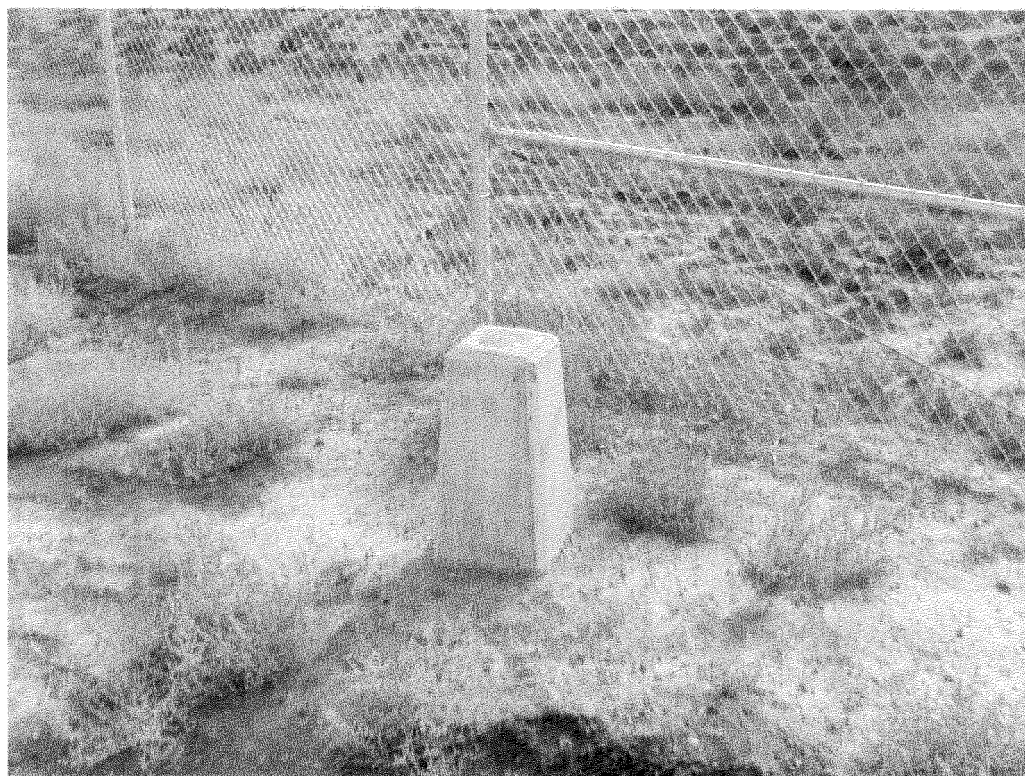
PB190830

Figure B-2. CFA-08, corner monument at northwest corner.

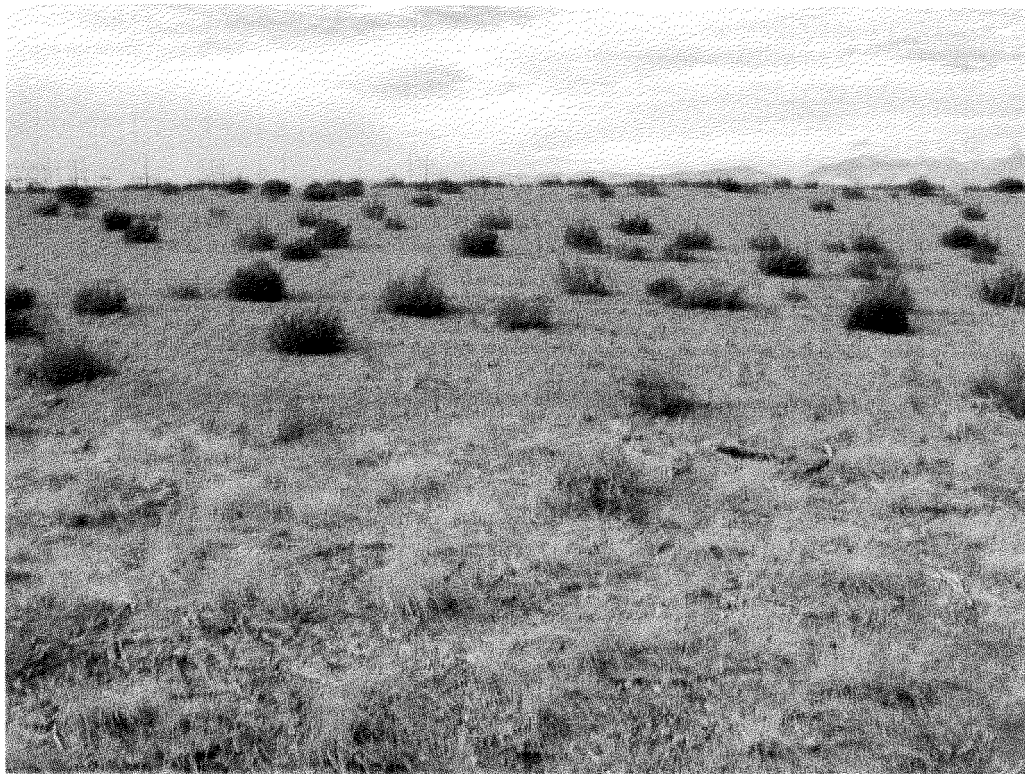
PB190832

Revegetation of the CFA-08 engineered cover was completed in the fall of 2002. Vegetation is visible on the cover. Grasses were noted around the base of the cover near the fence. Evenly spaced, small, bushy plants and small grasses also were noted on the entire cover. These plants and grasses will be identified and reassessed when they are green in the spring of 2004.

Figure B-3. CFA-08 vegetation on base and side cover.

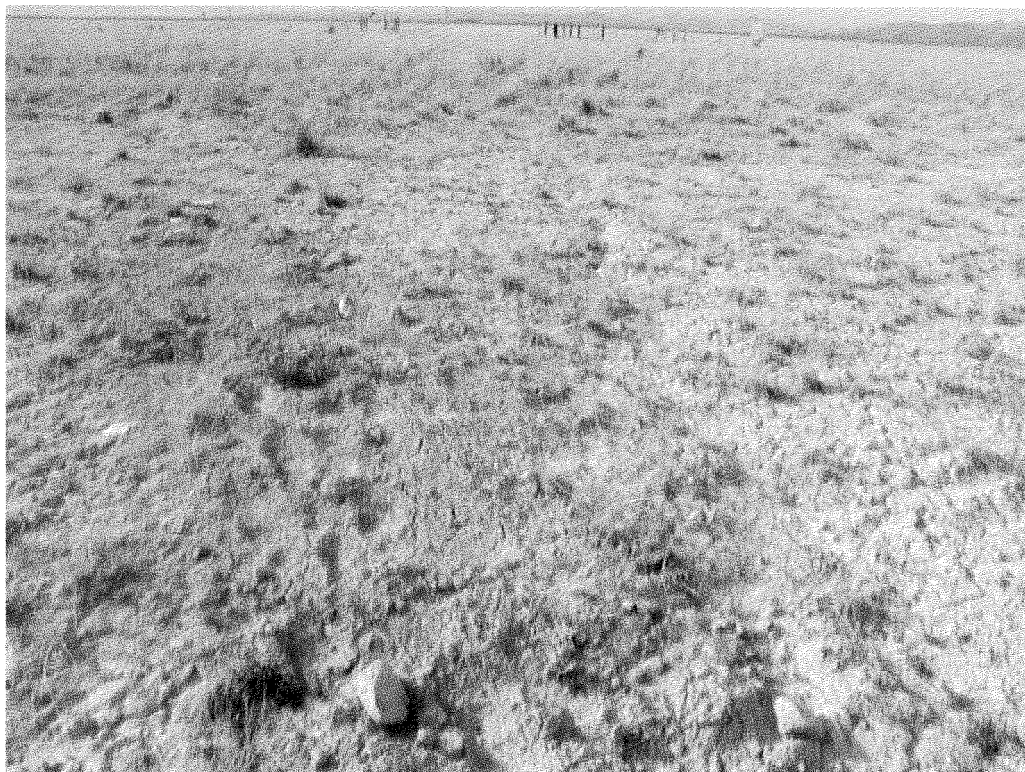
PB190841

Figure B-4. CFA-02 vegetation inside south entrance.

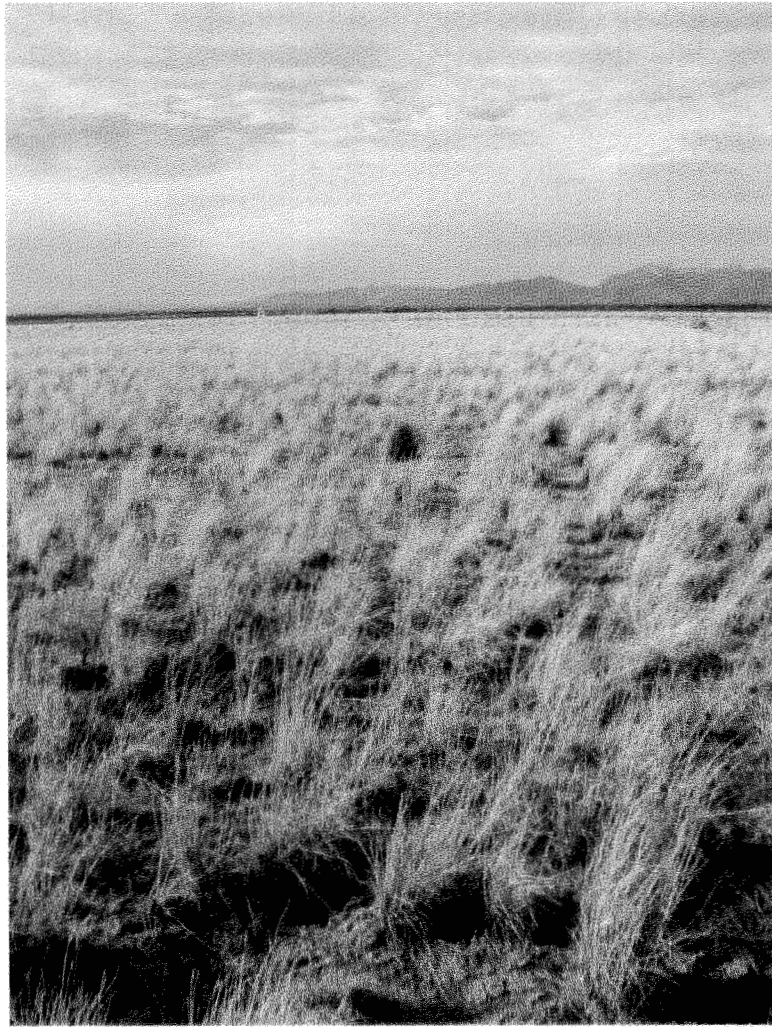
PB190843

Figure B-5. CFA-01 vegetation on middle of cover.

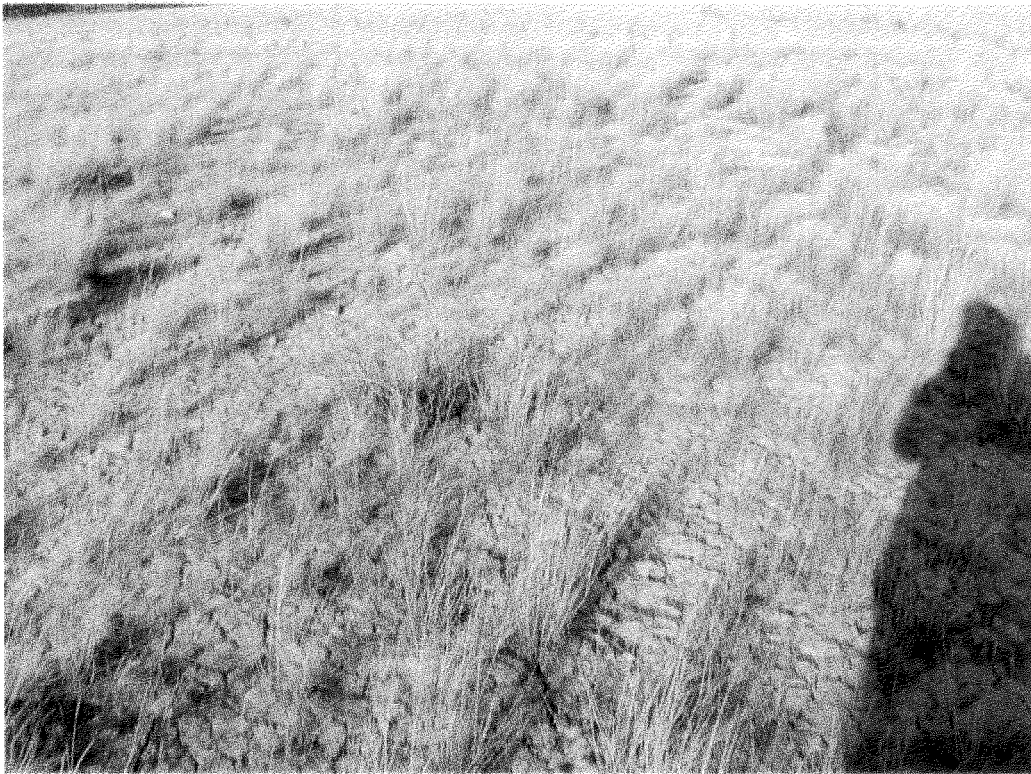
PB190846

Figure B-6. CFA-03 vegetation on cover, south side.

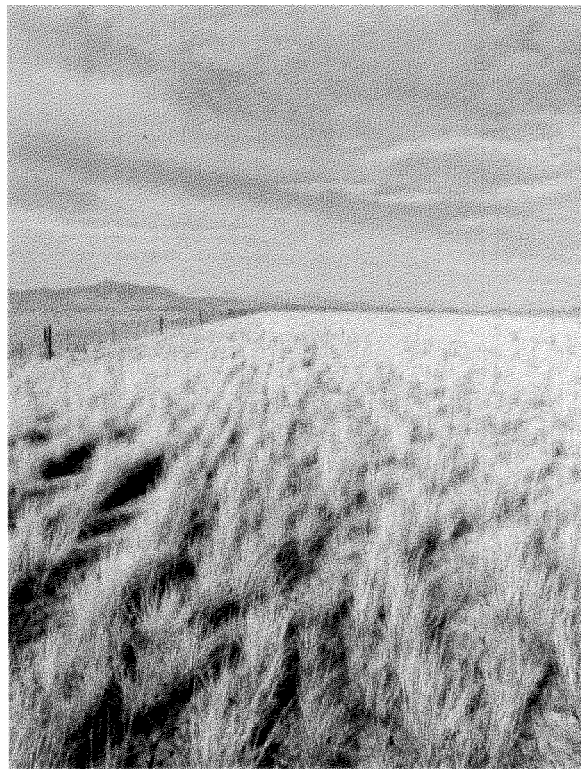
PB190847

Figure B-7. CFA-03 vegetation on cover, west side.
